## 2 Ring Belt

### 2.1.2 Scuffed rings

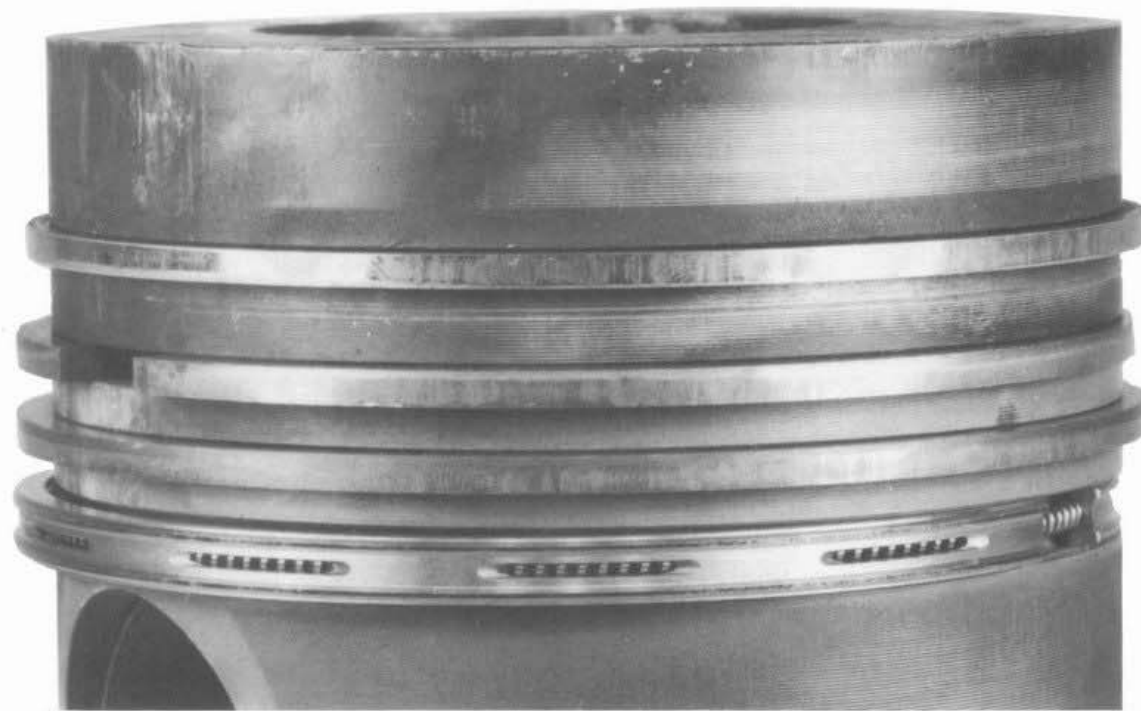
1

**Symptoms** The compression rings have seizure marks around their entire periphery -they are "scuffed". The cylinder bore which is also affected exhibits longitudinal marks. As a result, piston seizures may occur in the lower ring belt or upper skirt area.

**Cause and Effect** These ring seizures are initiated by lack of lubricating oil on the cylinder wall, which may have various causes. The thin film of lubricating oil which, under normal operating conditions, remains on the cylinder running surface, is completely scraped off by the rings. This causes localized metal-to-metal contact, resulting in fusion points caused by friction heat and unevennesses on the running surface, and also producing cracks in the material. Damage of this kind occurs particularly during the running-in phase with the engine under heavy load, since the rings have not yet achieved their full sealing effect. The combustion gases which then blow by burn off the lubricating oil film on the cylinder wall and can heat up the piston skirt with the result that, as a consequence of scuffed rings, piston seizures can also easily occur (see also 1.3). Overheating caused by preignition, an over-lean mixture or cooling defects (e. g. because of blocked or incorrectly adjusted spray jet nozzles) also create a high risk of ring seizure. The overheating causes the oil to carbonize in the ring grooves, thus further impeding the movement of the rings. They are no longer able to fulfill their sealing function, and the film of lubricant is destroyed.

**Remedy** Ensure correct engine adjustment to avoid faulty combustion (see als 2.1.7).

From the aspect of the ring configuration, a top compression ring which is chrome-plated or, even better, molybdenum-coated creates favourable conditions for the prevention of "scuffing" of the rings. Therefore, the configurations recommended by the engine manufacturer must not be modified. High engine load during the running-in phase, such as can occur at full load at high engine speeds, or, even more dangerously, labouring under high load at low engine speeds, must be avoided by all means.

Cylinder walls which are too smooth are just as damaging as those which are too rough. The aim should be to achieve a peak-to-valley height of 0.6 to 1.2  $\mu\text{m}$ . Crushed and smeared-over honing marks ("iron shell") should also be avoided. This leads to inadequate lubrication and, in addition, to heavy ring wear. Please observe our brochure - Honing - properly done !, no. 6903.
