2 Ring Belt

2.1.6 Ring wear on multi-piece steel-rail oil control rings

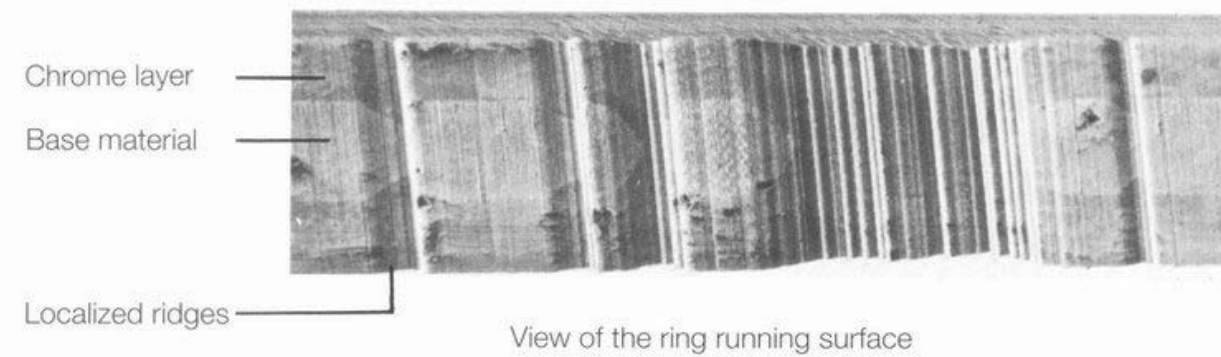
2.1.6

Symptoms The chrome layer (Chromschicht) on the running surface of the steel rails is worn locally down to the base material (Grundmaterial), leaving individual ridges extending in moving direction (Figure 2.1.6, magnification 50x). If the two steel rails of the oil control ring are laid one on the other in their fitting position, it can be seen that the ridges coincide on both rails and have the same distances. View of the rail running surface (Draufsicht auf die Ring lauffläche).

Cause and Effect These localized ridges (Erhebungen) are produced by grooves in the cylinder surface. The high contact pressures, both radial and axial, on the groove sides mean that, because of their design, the steel rails cannot rotate as easily as normal oil control rings. Above grooves in the cylinder surface there is practically no wear of the chrome layer, i.e. small chrome ridges are gradually left over which then completely prevent the rings from rotating.'

Grooves in the cylinder surface can be produced in various ways. If the cylinders are inadequately bored, grooves from previous use can remain, or cylinders installed in dirty condition can acquire grooves when put into service. Grooves can also be caused by scuffed rings. Lack of lubricating oil leads to ring seizures. Whilst seizure marks on the rings disappear as the result of normal wear after lubrication conditions are corrected, the marks in the cylinder remain. The steel rails of the oil control rings then run over these, thereby acquiring the characteristic ridges, which result in increased oil consumption.

Remedy Take care to achieve cleanliness during assembly. In the case of heavily worn or damaged cylinders, bore out to the next but one oversize. Never subject the engine to full load when cold and avoid both high engine speeds and "labouring" at low engine speeds.
