3 Piston crown

3.2.2 Melting of the piston crown and top land, Diesel engine

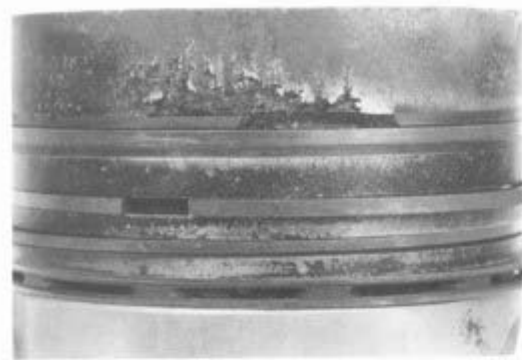
The top land in Figure 1 is locally molten above the ring insert.

Unburnt fuel because of ignition delays and spark failures is deposited in the clearance between top land and cylinder. On the one hand the consequence of this is increased ring wear (2.1.7) and on the other hand the collected fuel ignites without any control. In places, high temperatures exceeding the melting point of the piston material being 577~C are produced. Subsequently, the meltings in Figures 1 and 2 can even result in the total destruction of the piston shown in Figure 4. The causes for this faulty combustion are too low compression pressure (caused by wear, too large clearance or incorrect ignition timing), as well as faults in the injection equipment (such as carbonized or bad-locking nozzles or excessive injected quantities of fuel). The meltings at the rim of the combustion cavity and the edge of the crown in Figure 3 are to be attributed to increased injection quantities. Damaged injection nozzles or incorrect injection pump timing (for performance increase) lead to excessive temperatures.

Check that injection quantity and injection timing are adjusted as recommended by the engine manufacturer. Check injection nozzles for correct injection pressure and sealing. Ensure that the recommended clearance is met after cylinder head or block machining, if necessary assemble pistons with reduced compression height.

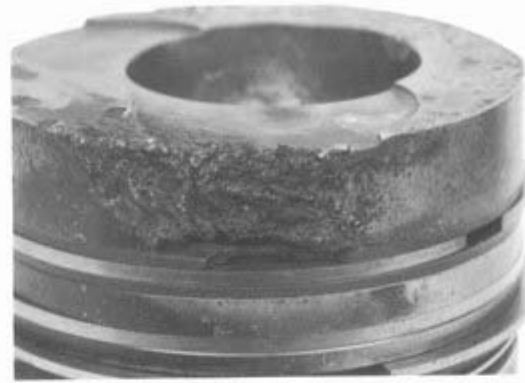
Figure 2 shows the progression of the melting over the entire top land width to the piston crown. In both cases, the ring insert broke out.

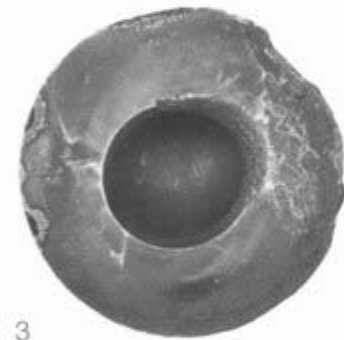
The piston crown in Figure 3 shows melting which has begun at the rim of the combustion cavity and at the edge of the crown, while in Figure 4 the crown and top land are completely destroyed.
