### 3 Piston crown

#### 3.3 Deformation of the piston crown

##### 3.3.1 Impacts on the valve or cylinder head

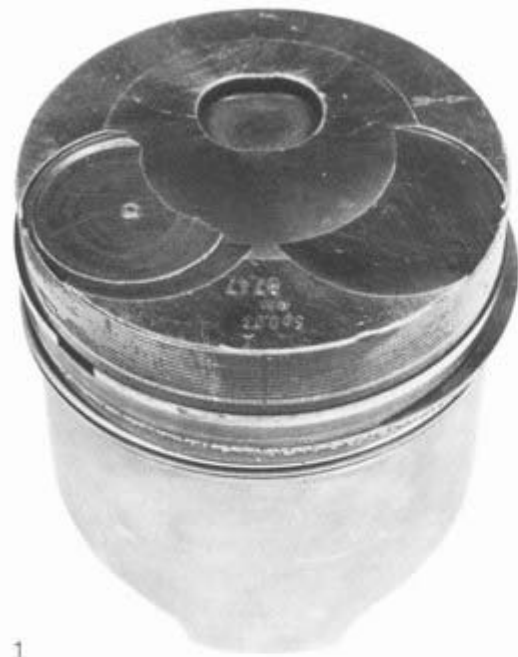
**Symptoms** Figure 1 shows a piston crown bearing the impact mark of a valve head. It can clearly be seen that the displaced piston material is raised up around the edge of the point of impact.

**Cause and Effect** In the case of the valve-head impact, it is clearly not the piston which is at fault. Damage of this kind is caused by incorrect valve timing (camshaft installation), broken valve springs, the build-up of oil carbon on the valve stem and incorrect valve clearance.

**Remedy** When assembling an engine, check that the control components are fitted correctly. Check the top clearance between the cylinder head and the piston crown, also the piston projection or recess distance for all cylinders. In cases where an engine produces harsh noise while running, check it before serious damage occurs.

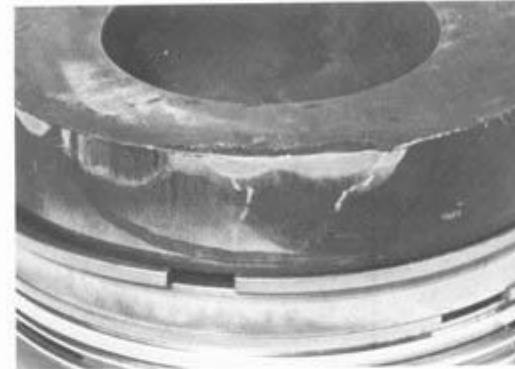
Figure 3 shows the case of a Diesel engine where the crown edge is deformed and the top land had hard cylinder contact.

Hard cylinder contact of the top land as shown in Figure 3 occurs particularly with pistons on Diesel engines with direct injection. A build-up of oil carbon on the piston crown, which is thicker than the top clearance, causes the piston to hit the cylinder head. Thereby the edge of the top land will be deformed and bear hard on the cylinder wall. The most serious results of this hard bearing are seizure and even fracture of the piston. Liquids (oil or fuel) which, for example with V-engines or horizontal engines, collect in the bottom "corner" of the combustion chamber after switching off a failing engine, may also cause displacements of material of this kind.

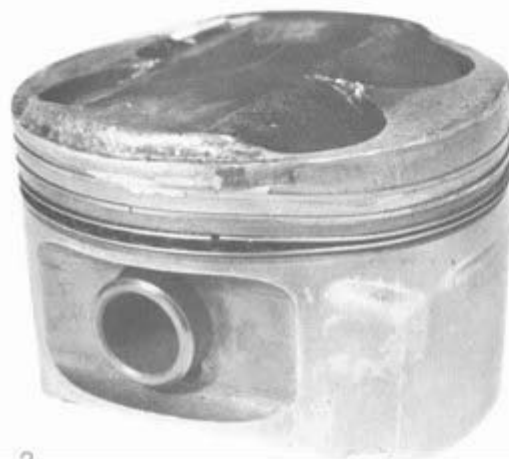
2

In Figure 2, the piston crown is deformed by approx. 5 mm, and has conformed to the shape of the combustion chamber of the cylinder head.

In the second case, it is probable that, because of a connecting rod bolt which has become loose, the piston stroke has become larger, and the piston has hit the cylinder head. Firstly, the piston material has been displaced into the combustion chamber, and secondly, in the quenched area, the ring belt is jolted down to the piston skirt. Breakage of the piston in this case was prevented only by the toughness of the forged piston material.
