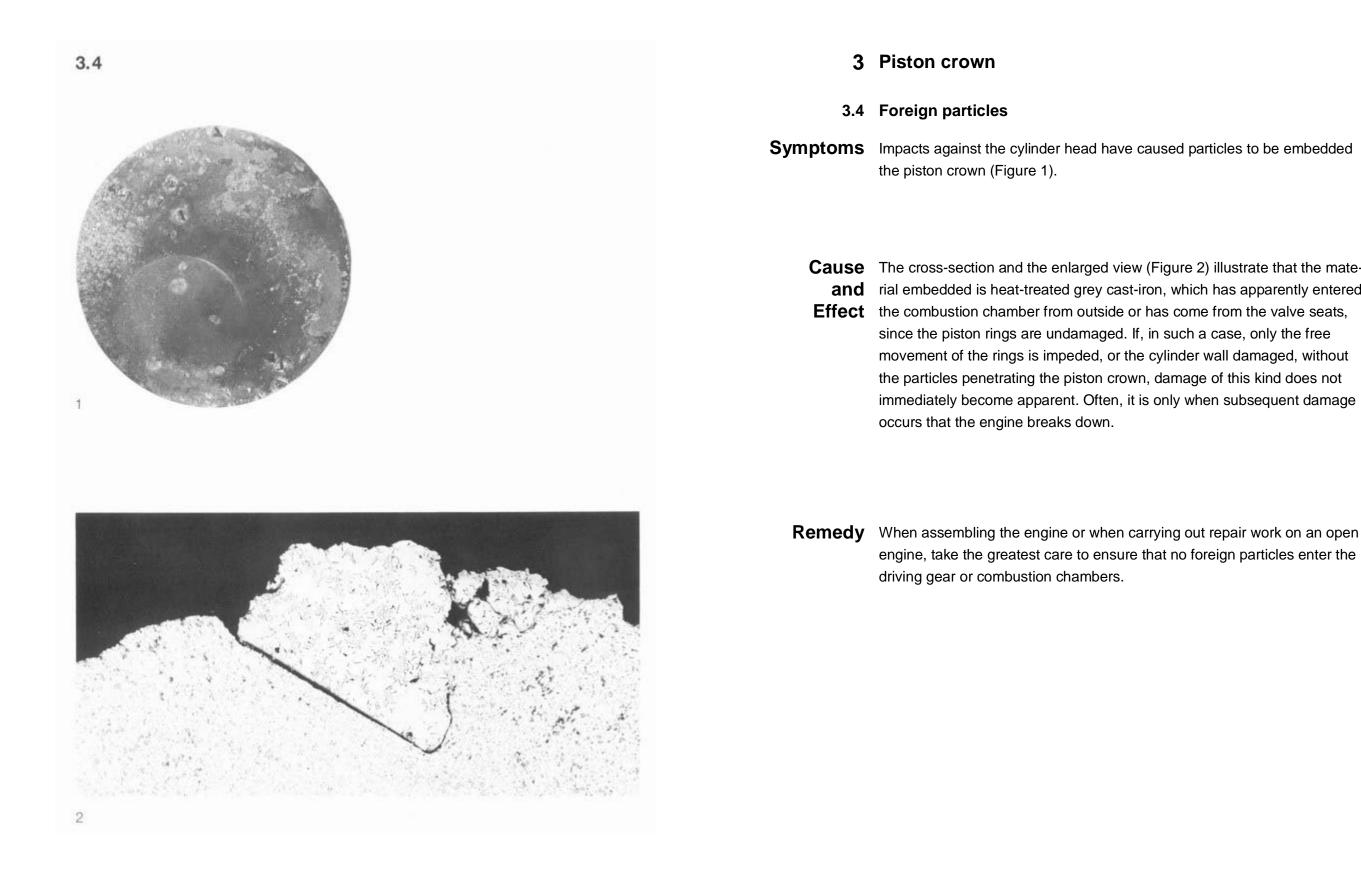
Cause The cross-section and the enlarged view (Figure 2) illustrate that the mateand rial embedded is heat-treated grey cast-iron, which has apparently entered Effect the combustion chamber from outside or has come from the valve seats, since the piston rings are undamaged. If, in such a case, only the free movement of the rings is impeded, or the cylinder wall damaged, without the particles penetrating the piston crown, damage of this kind does not immediately become apparent. Often, it is only when subsequent damage

engine, take the greatest care to ensure that no foreign particles enter the
