3 Piston crown

3.5 Breakage of the top land

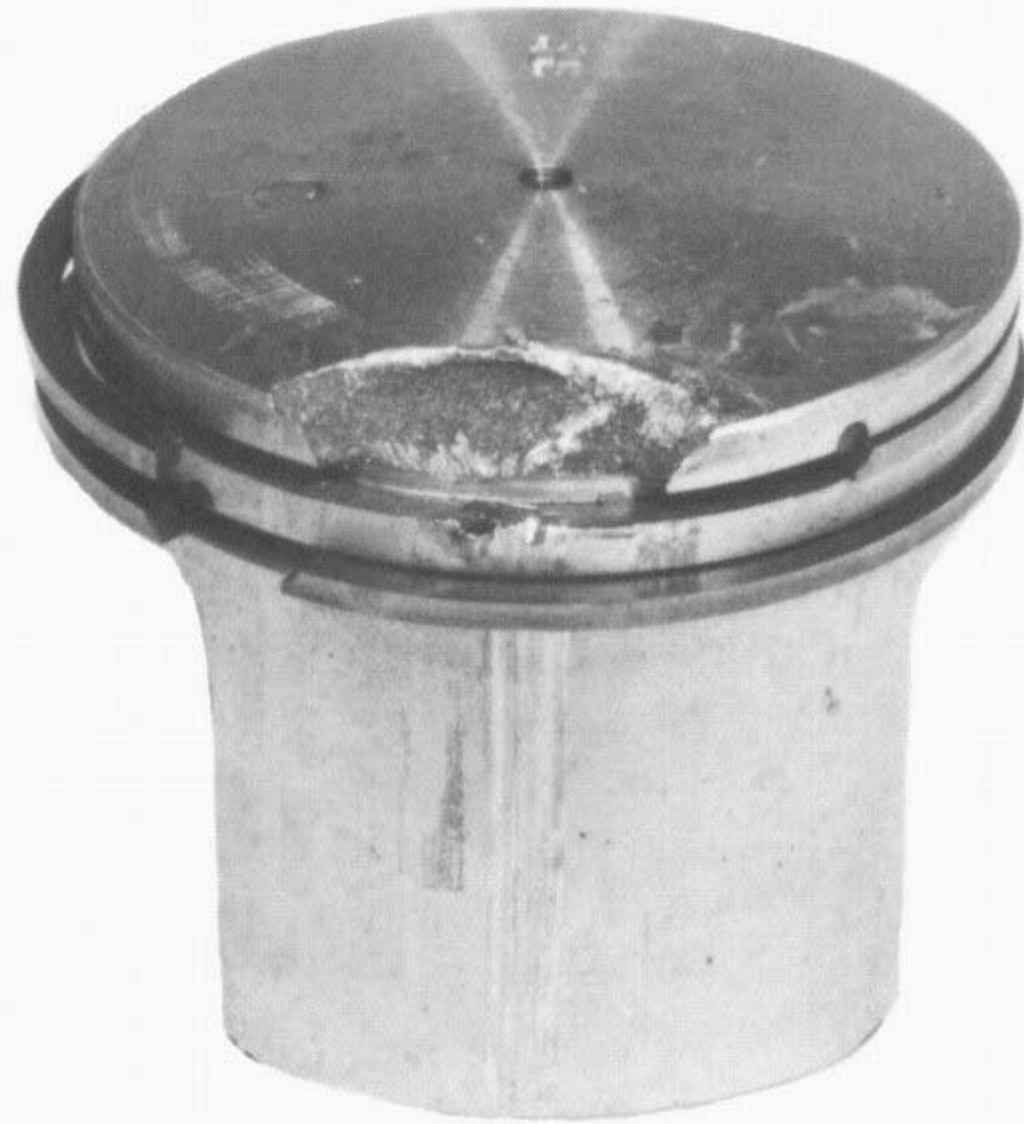
3.5

Symptoms The top land has been broken by forcible action. The piston exhibits no traces of previous overheating.

Cause and Effect The piston is from a two-stroke Otto engine which broke down as the result of faulty assembly.

During the fitting of the piston into the cylinder, the first ring sprang out into the outlet port of the cylinder. Heavy-handed assembly caused the top land to crack. After the engine had run for a short time, breakage occurred.

Remedy When fitting pistons, always use piston ring clamps. In the case of two-stroke engines check the direction of installation (ring gaps not at port outlets) and do not turn during installation. Never use force (heavy blows ' or similar) when fitting pistons.
