### 3 Piston crown

#### 3.6 Wear on crown edge and damaged top land

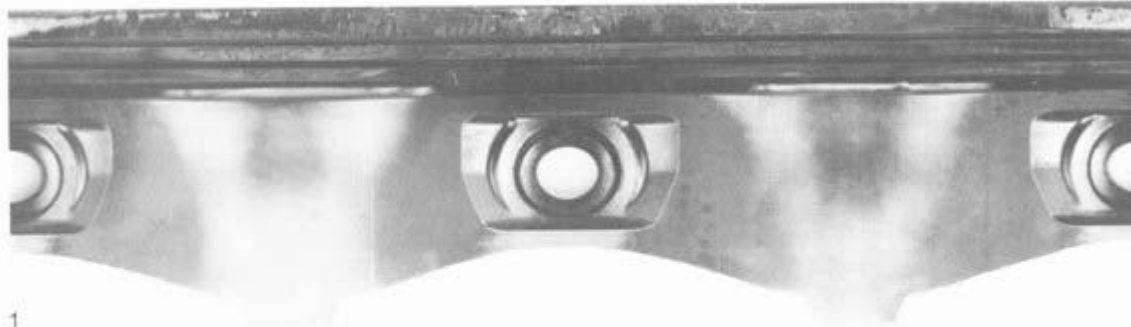
- Symptoms** On the Otto engine piston in Figure 1 as well as on the Diesel engine piston in Figure 2, the edge of the top land looks as if it has been "eaten away". Figure 4, taken with a scanning electron microscope, shows that this is not a case of melting but of abrasive wear.

- In Figure 3, a Diesel engine piston, piston material is displaced at the edge of the combustion cavity.
- Cause and Effect** On both engines affected, a build-up of oil carbon ("coke") in the cylinder bore chamfer has caused wear at the edge of the piston crown. Oil carbon can also build up on the edge of the gasket in the quench area of the cylinder head. Hard contact there leads to displacement of material and to abrasive wear, and the layer of oil carbon increases in step with piston wear. Preignitions may cause the piston edge to melt, thus accelerating wear.

- Remedy** Do not chamfer the top edge of the cylinder bore too strongly. Check that the cylinder head gasket is of the correct type.

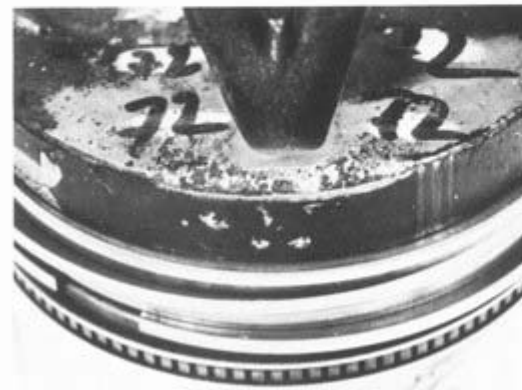
3

- In the case of swirl-chamber Diesel engines, deposits, particularly of oil carbon and combustion residues, occur on the hot underside of the swirl-chamber insert; the piston then strikes against these deposits. In many cases, wear is precisely localized to the outer and orifice diameters of the insert (Figure 3). In most cases, the displacement of material is caused by hard cylinder contact of the top land. In a laboratory investigation, the piston material exhibits no signs of melting.
