3 Piston crown

3.7 Erosion on crown and top land

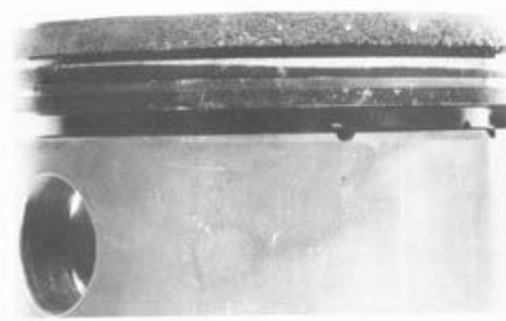
Symptoms The pistons in Figures 1 and 2 exhibit erosion-type surface damage in the area of the top land.

Otto engine (Figure 1)

High-frequency compressional vibrations with fast-igniting fuel-air mixture (low octane rating) together with raised temperatures lead to erosion-type surface damage on the crown edge, the top land, and the upper edge of the top ring groove because of "knocking" combustion (see also 2.2.2)..

Remedy Otto engine

Use only fuel with the recommended octane rating. Check the adjustment of the carburetor or injection equipment as well as the ignition timing regularly.

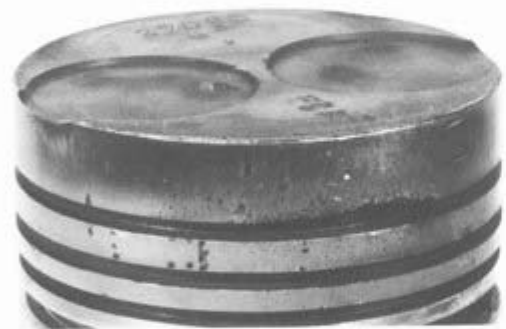
2

Erosion on the crown edge, top land and upper edge of the groove(Figure 2)

An excessive injection quantity, or fuel with insufficient ignition characteristics (cetane rating) leads to damage with a secondary combustion chamber effect.

Diesel engine

Clean or replace the injection nozzles and check that they are seated correctly. Check that the injection quantity and injection timing are set precisely. Use fuel with adequate ignition characteristics (cetane rating).

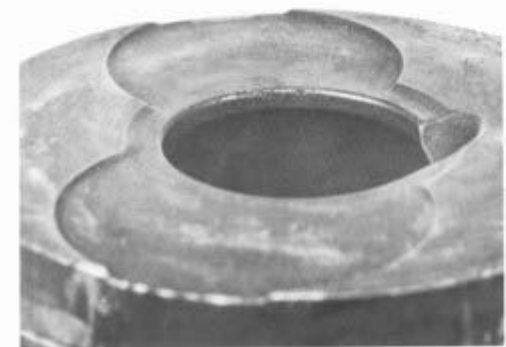
3

In Figure 3, this effect can be seen only on the rim of the combustion cavity, while in Figure 4 it can be seen, additionally, also on the crown.

Erosion on the rim of the combustion cavity (Figure 3)

A spray-over of fuel due to a faulty nozzle ignites on the hot surface of the combustion cavity rim and causes localized erosion of particles of material.

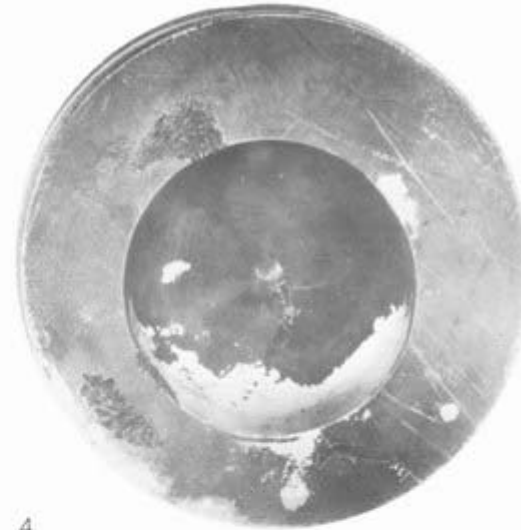
4

Erosion on the piston crown (Figure 4)

In this case, too, oversprayed fuel has ignited and created a secondary combustion chamber. This occurs particularly in the area underneath the hot exhaust valve (see also 3.2.2).
