## 3 Piston crown

## Melting of the piston crown and top land, 3.2.1 **Otto engine**

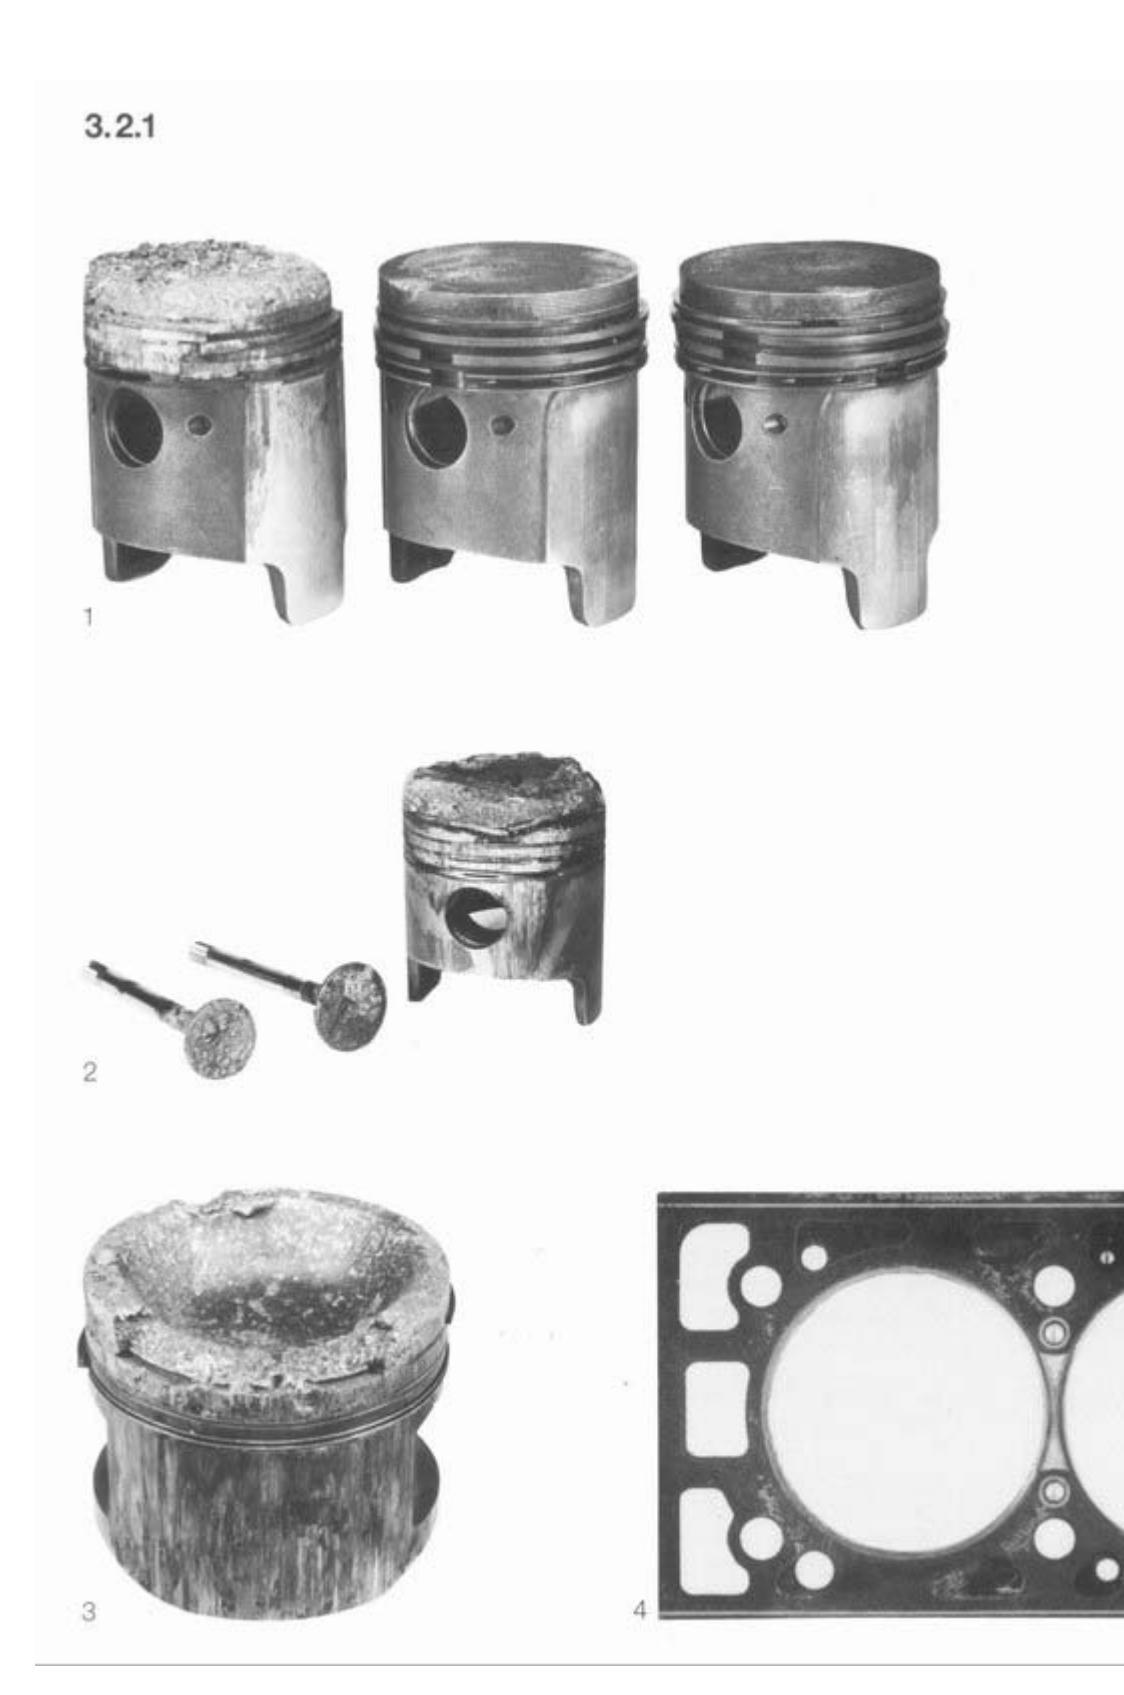
**Symptoms** The three pistons in Figure 1 illustrate the progression of the melting. The right-hand and centre pistons have small fused areas at the edge of the crown. On the left-hand piston, the crown area has melted away. Similar to Figure 1, Figure 2 shows a further stage of the destruction. Even on the stem of the exhaust valve (left), there is melted-away piston material, showing that a part of the piston "has left the engine in a molten state". Figure 3 shows the locally-molten and broken out bowl rim and top land. The eyelet of the cylinder head gasket in Figure 4 exhibits deformations and is pressed together over a part of the circumference, at the rim on the cylinder side.

**Cause** Uncontrolled preignitions caused by glowing combustion residues, valves which have and overheated because of inadequate valve clearance and incorrectly-fitted or damaged **Effect** cylinder head gaskets cause very high temperature peaks, which can be as high as the melting point of the piston material, approx. 577 ~ C. An over-lean fuel-air mixture caused by wrong carburetor adjustments or faults in the mixture controls or the injection nozzles (dirt) for petrol injection equipment as well as fuel with an insufficient octane rating and an over advanced ignition also lead to faulty combustion (see 2.2.2 and 3.7). As a consequence, preignition may be generated which leads to the damage pattern described.

**Remedy** Use recommended fuel (octane rating). Check correct adjustment of ignition, carburetor, and injection equipment.Do not immediately subject vehicles which have been used for a consider-able period only for short-haul driving to full load the next time you drive on the motorway. If the sealing surfaces of the cylinder head or of the cylinder block have been reworked, fit a thicker gasket, or for oversize pistons, ensure a smaller compression height.
