1-9 Corrosion on the piston skirt

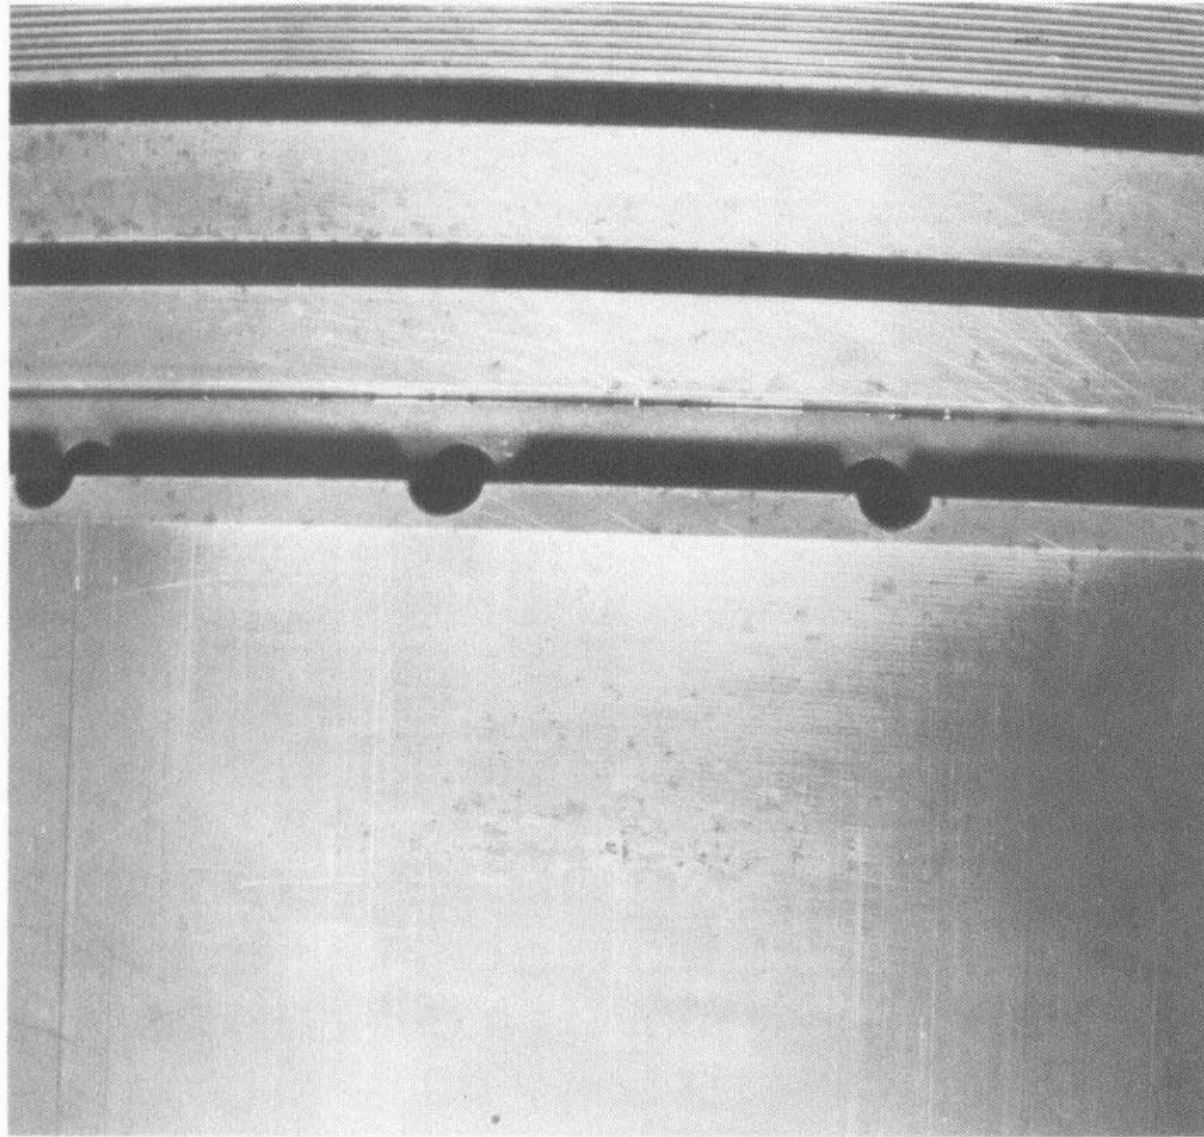
1.9

Symptoms The piston skirt exhibits hole-shaped pitting.

Cause and Effect This pitting has been caused by intercrystalline corrosion. The cause of this can be an unsuitable decarbonizing solvent which has been allowed to act for too long.

Remedy Pistons which have been removed and which are intended for reuse should be cleaned only with well-proven brands of decarbonizing solvent, in accordance with the manufacturer's instructions.
