3 Piston crown

3.3.2 Yielding of the piston crown

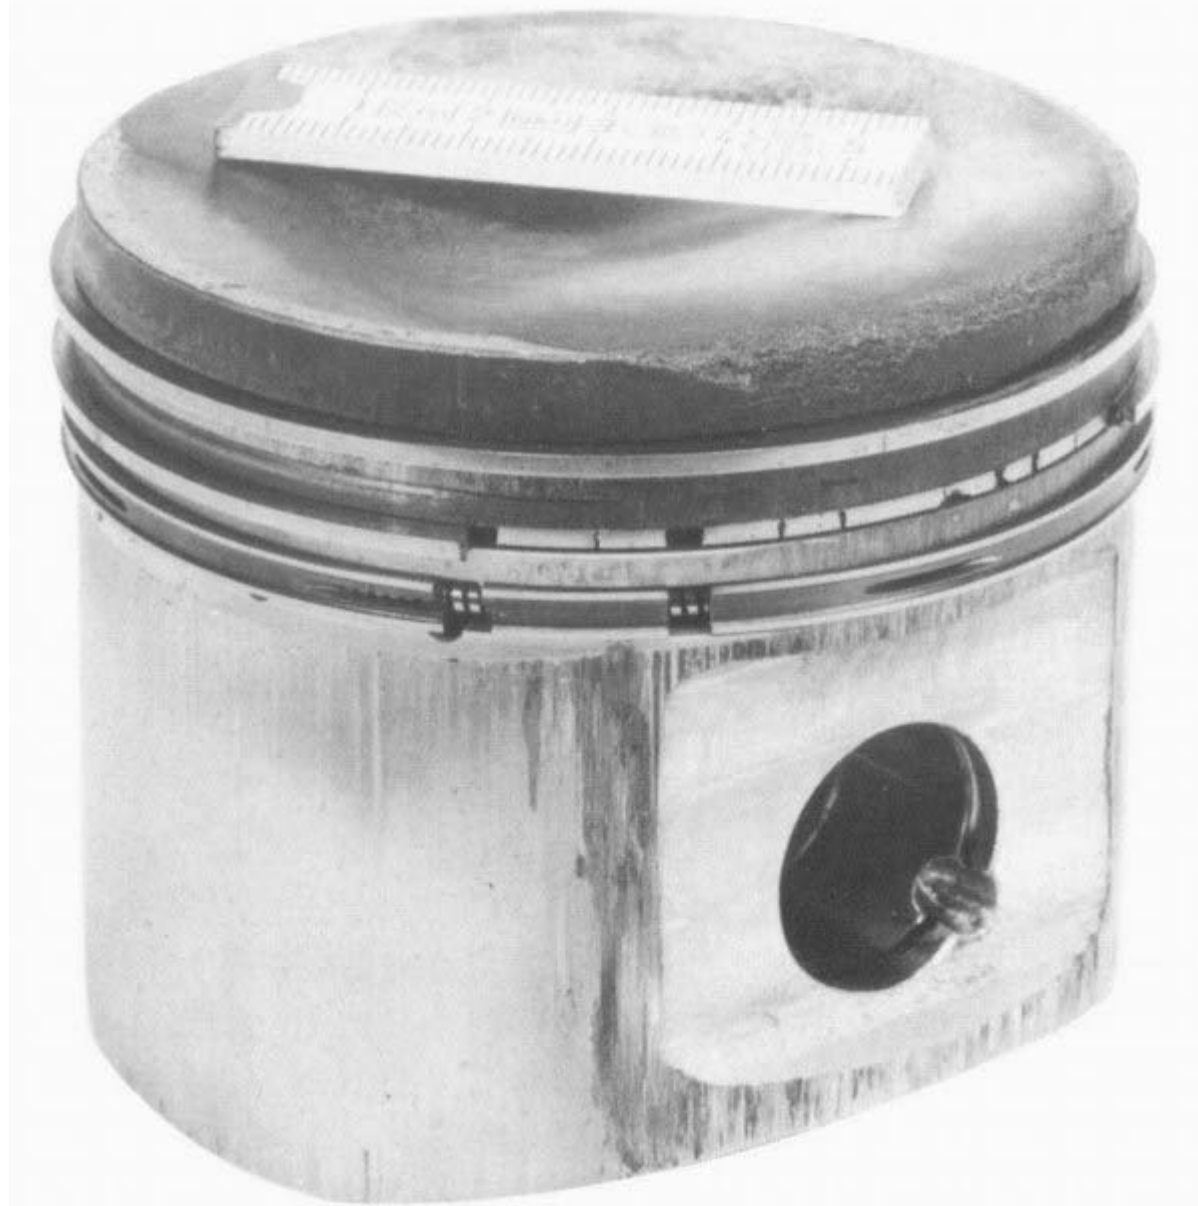
3.3.2

Symptoms The piston crown is sunk in. There are no traces of impact.

Cause and Effect The faulty combustion process (preignition) caused excessive temperatures without localized overheating. The strength of the material has been reduced by this overheating, with the result that the piston crown is no longer able to withstand the combustion pressures and has assumed a concave shape. On further heating, the piston crown would then develop a hole.

Remedy Prevent over-lean carburetor settings by carrying out regular checks and, in the case of petrol engines with fuel injection, check that the composition of the mixture is correct.
