## **1** Piston Skirt

## 1-7 Wear caused by dirt

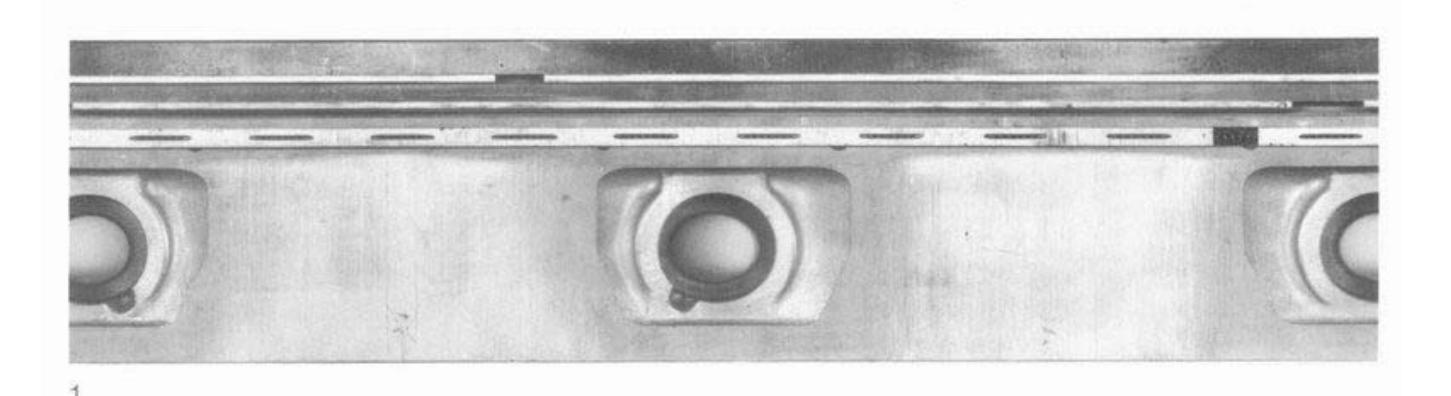
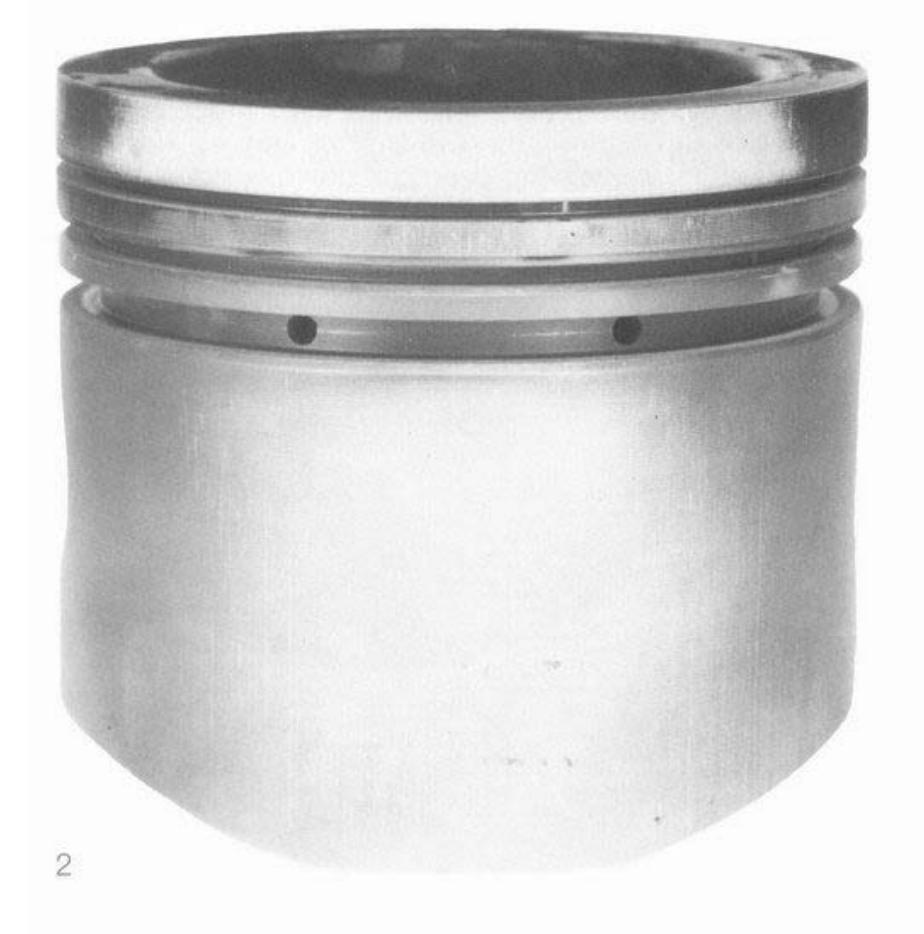
## 1.7

**Symptoms** Complaints are often made about high oil consumption,heavy blow-by with fuel condensation in the oil,loss of performanceand poor starting behaviour,particularly in cold weather. On both thrust faces, the piston exhibits a broad, matt wear pattern. The machining profile has been abrased. Individual, small scores are superimposed. The rings have a large closed gap and exhibit radial wear knife-sharp ring edges. The ring lands of the oil control ring(Figure 2) are entirely worn by abrasion. The groove sides also exhibits heavy axial wear. The piston skirt or other worn areas of the piston have a dull grey satin appearance(matt surface with abrasive machining profile)

The dull appearance of the surface indicates heavily contaminated oil. In most cases it is still possible to determine whether the dirt has been introduced by the oil or by the intake air. If ring wear is heavier towards the piston crown, particularly in axial direction, then the dirt certainly entered via the intake system. If, on the other hand, the lower rings are more heavily worn (particularly the oil control ring as shown in Figure 2), and the piston skirt exhibits heavy wear, then the cause is contaminated oil. A special indication to this is the wear pattern of the gudgeon pin shown in Figure 2.2.1.5.

If the piston only exhibits vertical scratches and no dull wear pattern, an( if the rings mainly show radial wear (less axial wear on the top ring than described in 2.1.5) the cause lies in the honing of the cylinders. Either the cylinder bore was not carefully washed out after honing, or the honing marks were crushed and the material flakes on the surface ("iron shell") caused by this were then worn away. Scuffed rings may also be a further result (see 2.1.2).

Exercise great care during assembly (in accordance with the engine manufacturer's instructions). Clean or replace intake filters, particularly inserts, regularly, as appropriate to the dirt concentration under operating conditions use new gaskets, and check the intake system of the engine for leaks. Use honing stones which cut cleanly. Clean cylinder bores carefully after honing
