3 Piston crown

- 3.1 Burnt-through piston crown
- **Symptoms** The piston crown in Figure 1 has a hole which looks as if it was caused by a bullet. The surrounding piston crown surface is usually covered with fused-on piston or burnt through in places. 3.3.2).

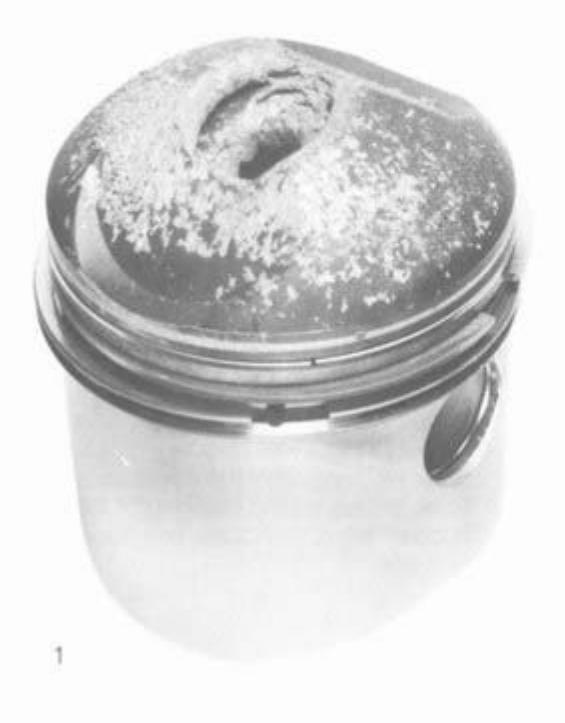
> A spark plug with a too low thermal coefficient caused the damage of the piston shown in Figure 1. Preignitions triggered by the overheated spark plug insulator bottom resulted in local overheating of the piston material and fusing of the crown. The spark plug can also be damaged due to knocking combustion (3.7) and can then likewise trigger preignitions. Damage shown in Figure 2 mostly originates from preignitions which are the consequence of a cylinder head gasket damaged by knocking operation. Causes for knocking combustion with resulting preignition are spark advance, too lean fuel air mixture, a defective injection equipment or low-octane fuel. Preignition also leads to similar damage as a consequence of knocking operation due to combustion residues. **Diesel engine**

Remedy In the case of Otto engines check correct adjustment of the carburetor and injection system as well as leaks in the intake system. Fit spark plugs with the correct heat rating. Check the ignition timing and ignition advance devices (centrifugal and vacuum controls). In the case of Diesel engines, replace nozzles which drip after delivery (irregular running noise) and check the injection pump. Use only fuel which has adequate anti-knock properties.

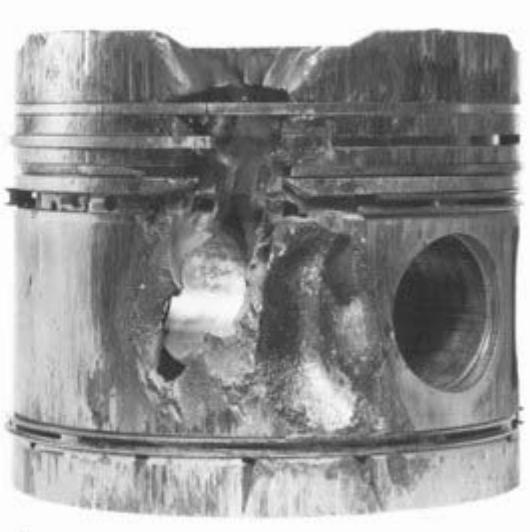
material. In Figure 2, the top land is charred away, and the ring belt is broken through
